STATE OF CALIFORNIA  
DEPARTMENT OF TRANSPORTATION  
DIVISION OF CONSTRUCTION  
OFFICE OF TRANSPORTATION LABORATORY

January 1980

APPRAISAL OF ALTERNATIVE METHODS FOR  
RESTORATION OF PAVEMENT SURFACE TEXTURE

1. REPORT NO. FHWA/CA/TL-80/02		2. GOVERNMENT ACCESSION NO.		3. RECIPIENT'S CATALOG NO.	
4. TITLE AND SUBTITLE APPRAISAL OF ALTERNATIVE METHODS FOR RESTORATION OF PAVEMENT SURFACE TEXTURE				5. REPORT DATE January 1980

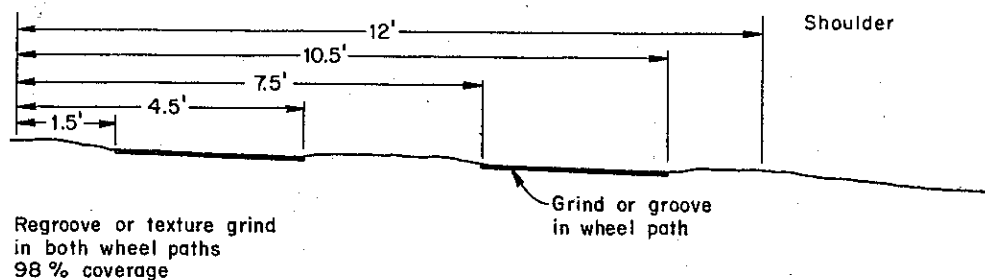
Figure 11

PROPOSED PATTERN FOR REGROOVING OR  
RETEXTURING BY GRINDING

treatments of restoring worn, grooved surfaces but the potential for problems seems high at this time. Because the absence of grooves is primarily in the wheel path, regrooving might be done only in the wheel path. A proposed pattern is shown in Figure 11.

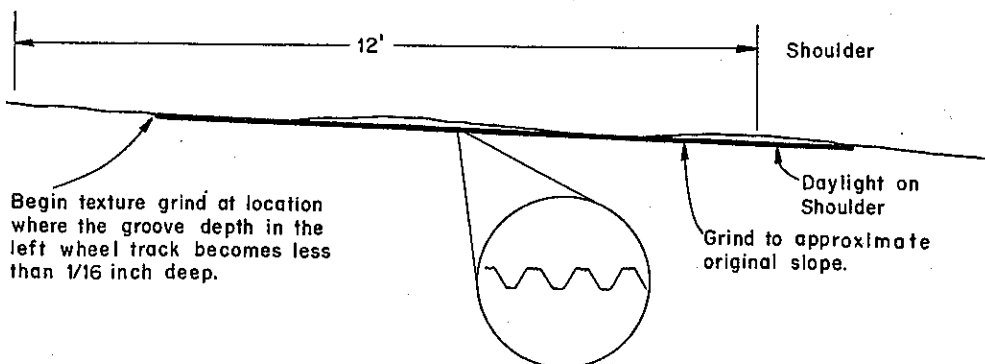
Figure 12

PROPOSED PATTERN FOR RETEXTURING BY  
GRINDING IF FUTURE REGROOVING IS PROBABLE

If regrooving is determined to be unsatisfactory, then a texture created by grinding in each wheel path is proposed for consideration. This texture grinding should be performed with great care. Excessive grinding in the wheel paths will provide channels to collect water and this must not be allowed. There may be some locations where a very high friction demand is expected and texture by grinding may be considered marginal. For such locations it seems prudent to grind as much of the lane as practical to remove existing grooves and prepare the surface for grooving should it be

-Grind that portion of the lane from the left wheel path having shallow grooves across the lane to the shoulder area. This would provide surface texture, accommodate surface runoff, and provide a reference plane if standard grooving becomes necessary.

1. Establish test sections of old, worn grooved pavement and regroove only the wheel tracks to determine the feasibility of this treatment.
2. As an alternate to regrooving, texture the worn, grooved pavement in the wheel tracks only by grinding, to determine the feasibility of this treatment.
3. If it is suspected that wheel track grinding alone may not provide adequate texture for a location, the lane should be ground from the left wheel track onto the right shoulder at the existing cross slope (see Figure 12) so that pavement grooving can be performed as needed in the future.

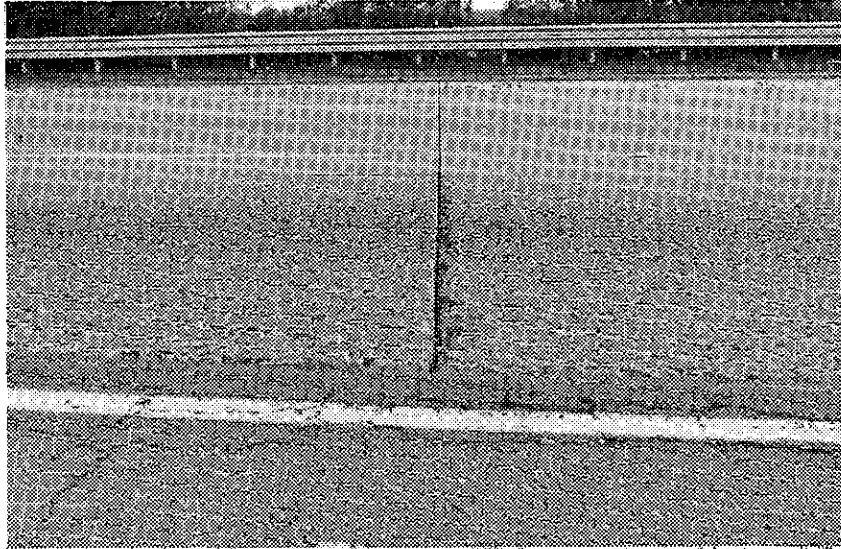
Example of spalled joints after cold planing  
a PCC roadway.

Experience in California has demonstrated that cold planing portland cement concrete pavements results in considerable spalling at the transverse joints.\*\* Figure 10 illustrates this spalling problem. Spalling appeared to be reduced by temporarily sealing the joints before milling but subsequent investigations indicate that spalling at these joints occurs under continued traffic exposure. The spalling is considered excessive and unacceptable(6).

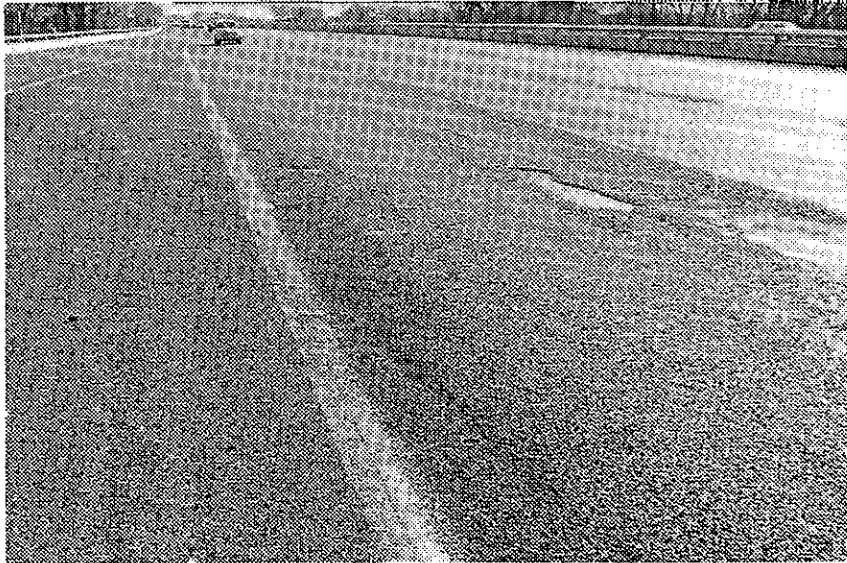
Figure 9

This open graded asphalt concrete surfacing has raveled in several locations. The primary reason for the failure appears to be placement at marginally low temperatures. Also, a light and erratic tack coat probably contributed to the loss. Several failures have been patched with a DGAC mix.

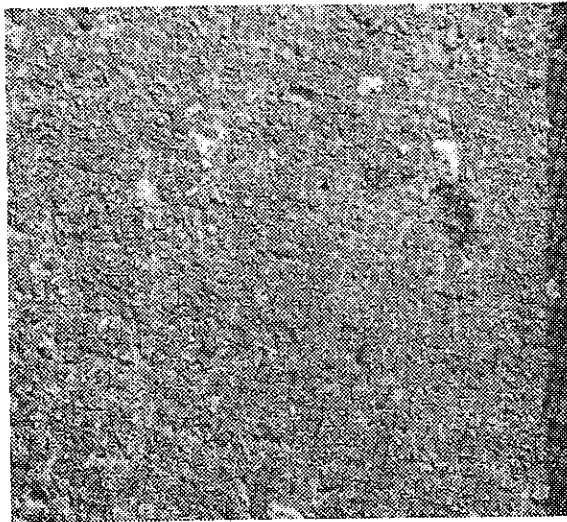
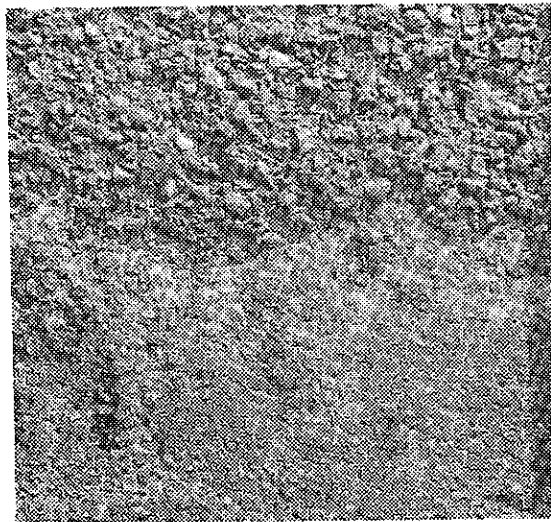
Figure 8

PCC surface adjacent to OGAC overlay.

Minimal ravelling at the end of the overlay.

The inevitable reflection cracks over the joints of the PCC slabs have been treated with crack sealant. The overall appearance of this project is very good after 5-1/2 years of service. Figures 6, 7 and 8 depict the 5-1/2 year old surfacing. Although some reports indicate that bonding thin AC layers to PCC may be a problem, it appears that OGAC can be an acceptable improvement of worn PCC as well as worn AC surfaces. It is unclear whether the surface improvement by OGAC should be limited to roadways with moderate truck traffic or if it is acceptable for all roadways regardless of

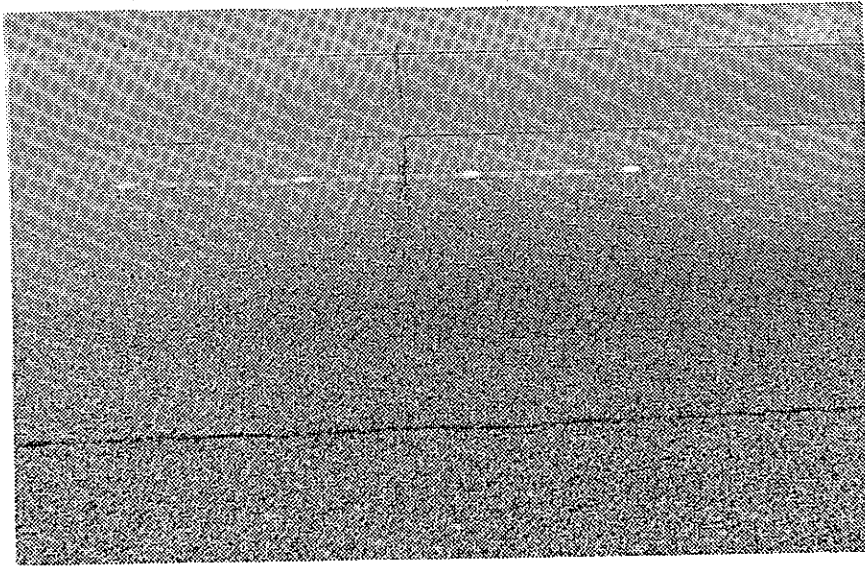
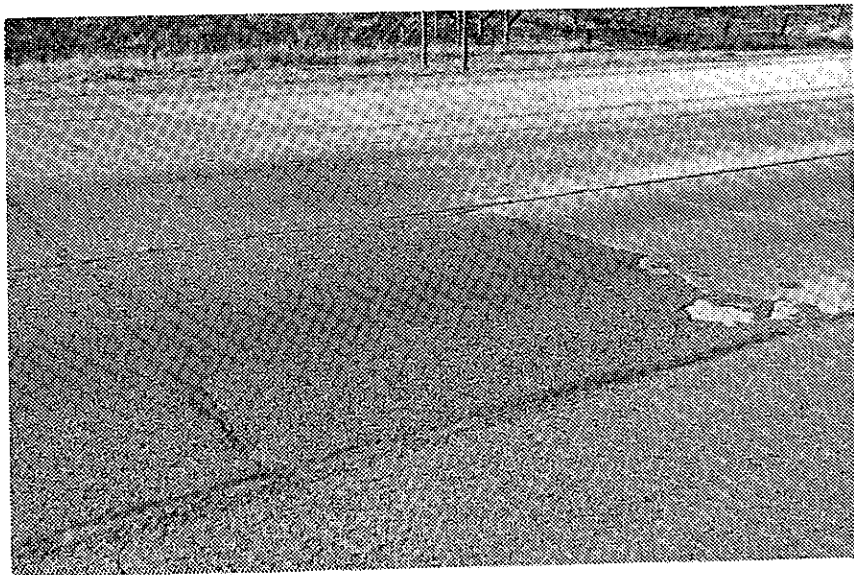
Figure 7

Reflection cracks will spall if not sealed.

End of overlay northbound exhibits the only bond problem on the project.

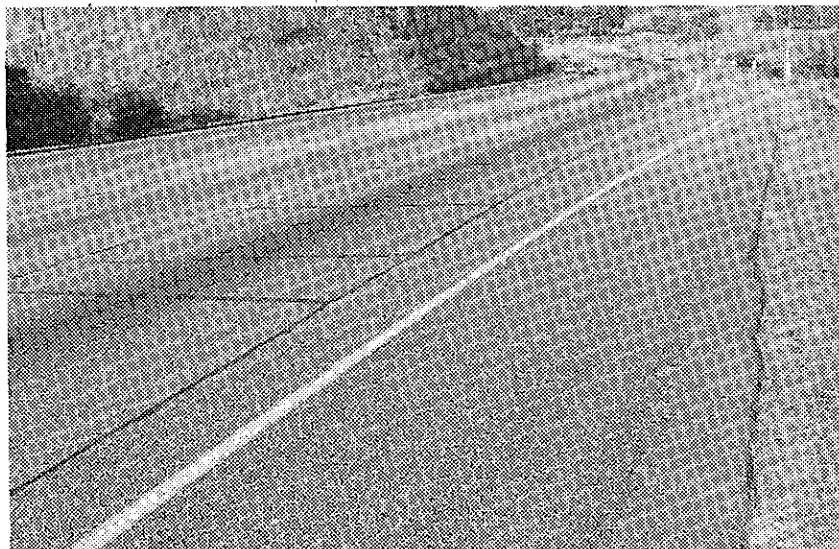
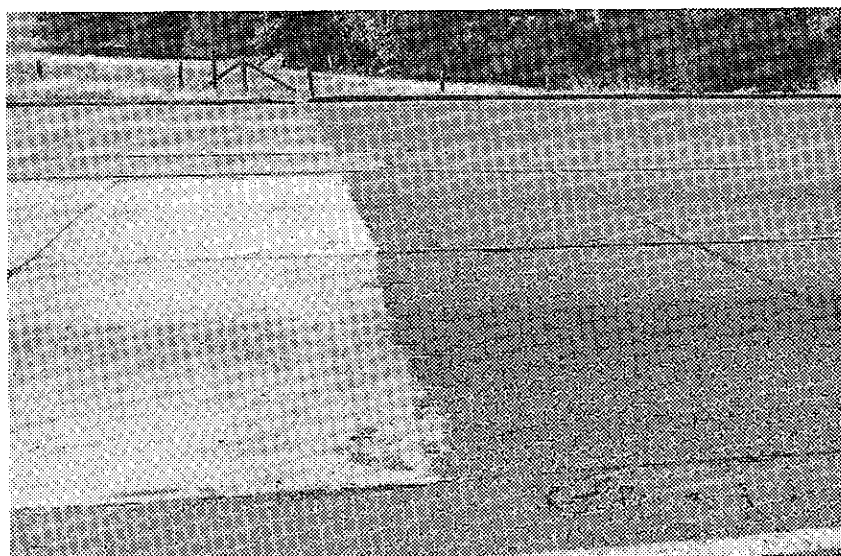
Figure 6

OGAC placed over PCC to delineate a turn lane.

Transition indicates a very good bond to the PCC.

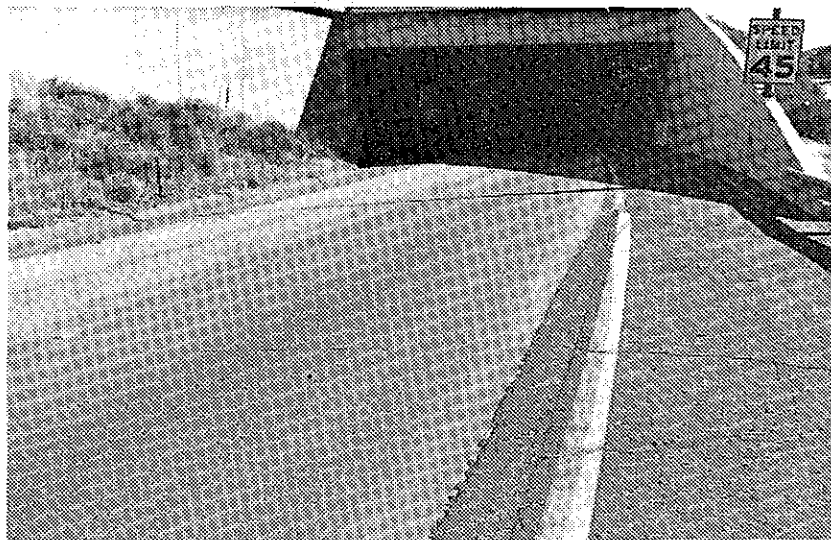
Figure 4

Additional texture was provided to this grooved PCC roadway by grinding.

There is one dramatic illustration where grinding has improved texture of a heavily traveled roadway that had previously been grooved. This roadway is a truck bypass that carries approximately 2.7 million EAL annually (AADTT=12,600). The pavement was grooved after a major accident occurred in a tunnel. After the grooving operation, it was decided that a light grinding\* of the surface was justified to provide additional texture. After two years, it appears that the texture is resisting the polishing action of the heavy traffic. Pictures of the texture and the geometrics are shown in Figures 4 and 5.

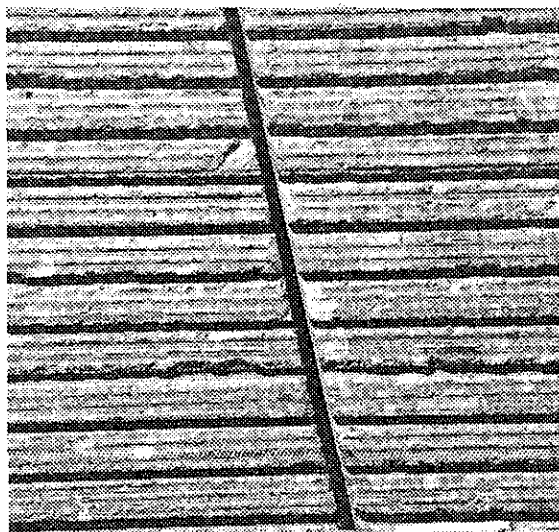
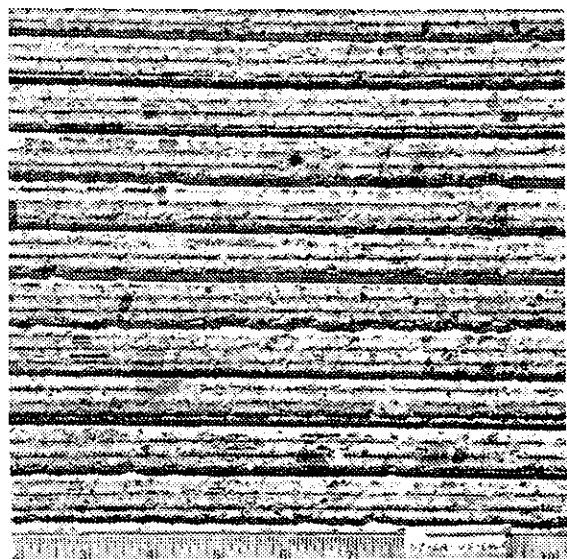
Figure 5

Example of texture by lightly grinding (texture-grind) a grooved PCC pavement

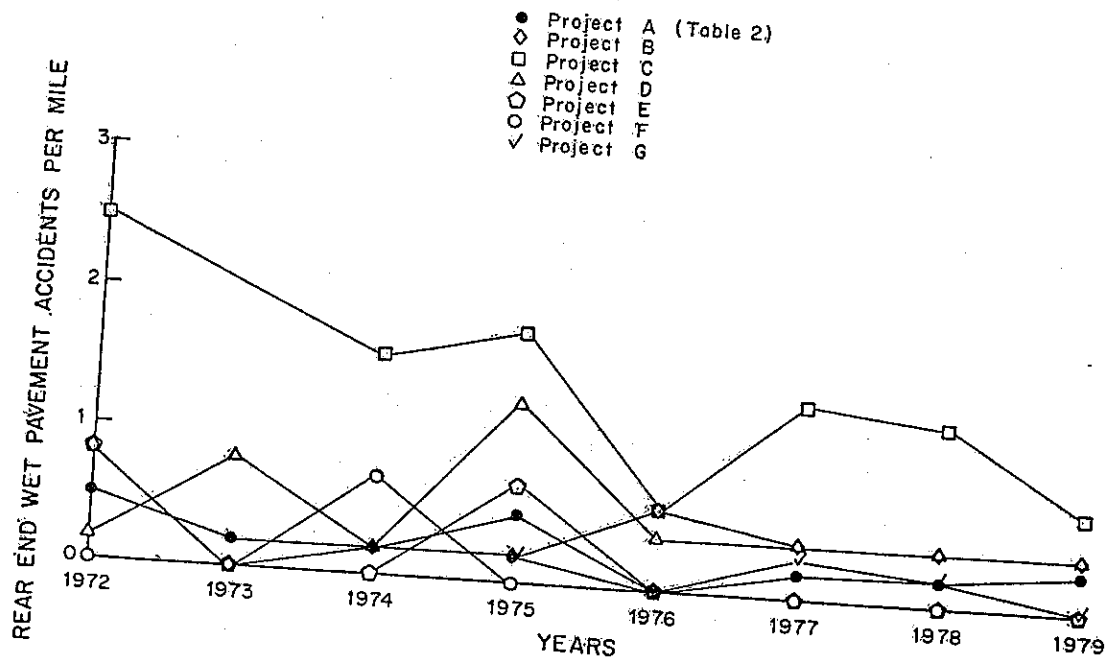
FIGURE 3

# FREQUENCY OF REAR END TYPE WET PAVEMENT ACCIDENTS PER MILE

Several years of wet pavement accident statistics are shown in Table 2 and Figure 3 for the areas that were ground in the outer lanes. Although several of these ground locations are not in areas that have the higher friction demand such as curves or weaving sections the general trend of wet pavement accidents indicate that grinding provides an acceptable texture. Rear end type accidents were selected in preference to total wet pavement accidents because sideswipe and other classifications are less likely to relate to one lane and therefore might bias the data. If the ground texture becomes polished and ineffective it is probable that the wet pavement accident frequency and especially the rear end accident frequency would increase.

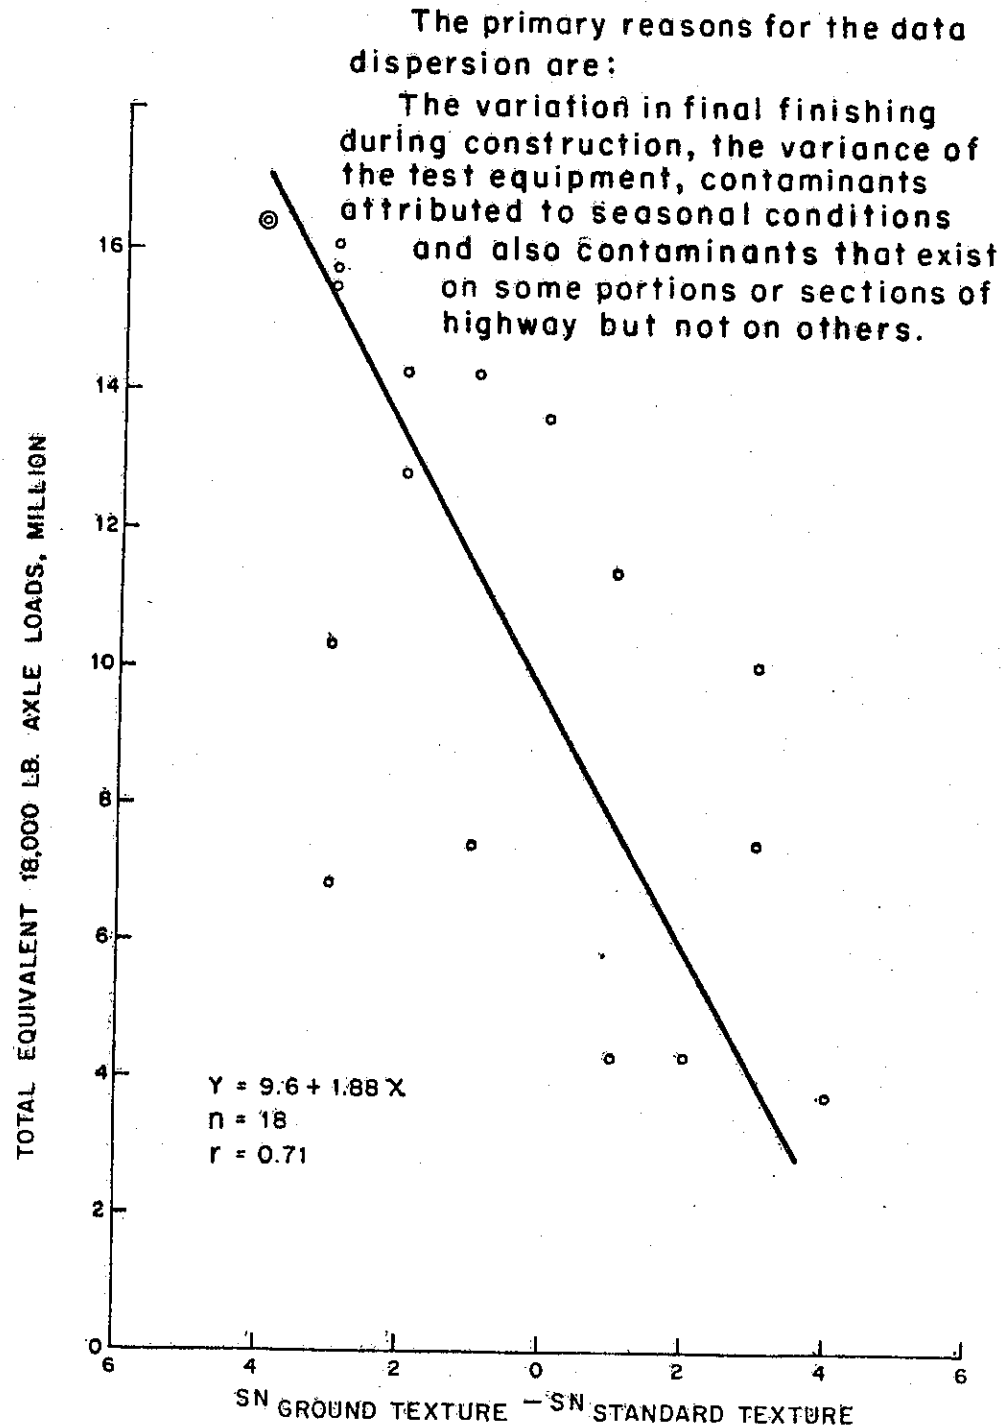
Figure 2

# COMPARISON OF THE RESISTANCE TO POLISH OF GROUND TEXTURE AND STANDARD TEXTURE OF PCC PAVEMENTS AS MEASURED BY SKID TESTS

The total number of equivalent 18,000 pound axle loads (EAL) that have traveled the roadway since the grinding operation are shown in the table. These values are compared to the respective differences in skid number in Figure 2.

If the assumption is made that the effectiveness of the grinding is lost when the skid number of the ground area reaches that of the standard texture, then the average texture life of a ground PCC surface is approximately ten million EAL or about six or seven years for these heavily traveled roads. It is probable that, as in grooving, texture-grinding provides some benefit to the motorist (lateral stability) that is not reflected in the longitudinal skid test measurements and therefore a longer effective service life may be obtained.

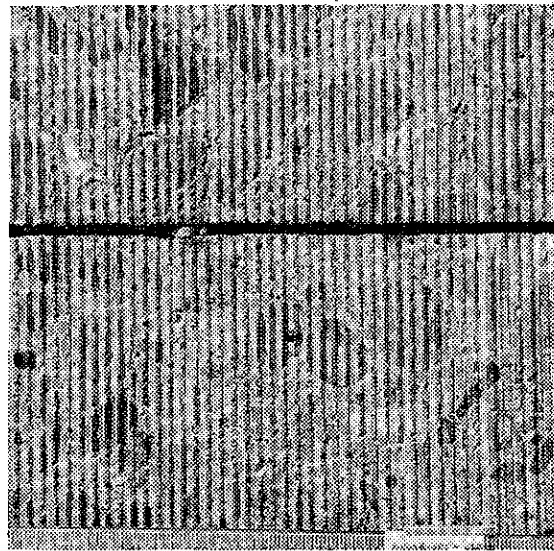
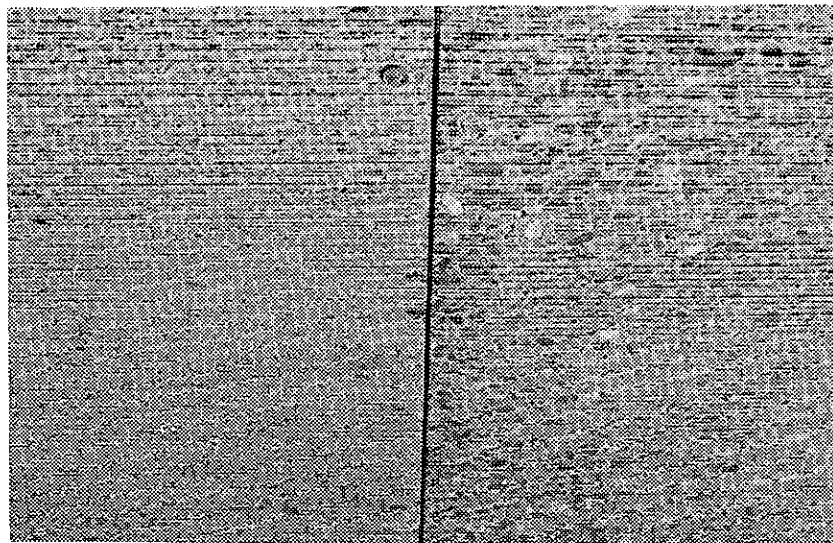
Figure 1

Grinding to improve rideability leaves a satisfactory texture providing the wheel path on the leave side of the joint is also textured by the grinding (deeper cut for surface texture).
